Inspection Report

**John Smith
1234 Street St
Dayton, OH 45458**

Inspected by: **Mark Bromer**

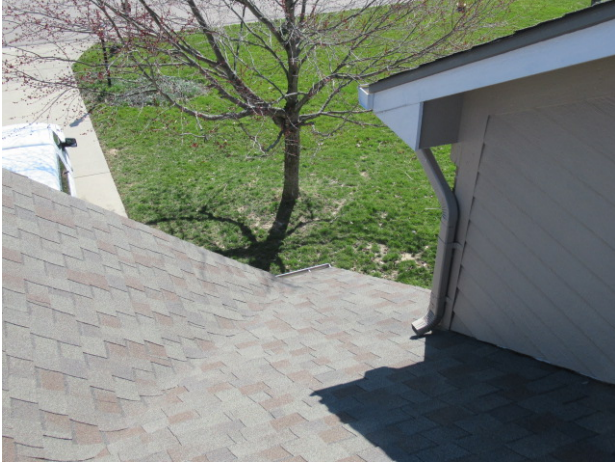
#R1

- 19 1. Down spout is draining onto roof above garage. Recommend extending down spout to lower gutter to help extend the life of the roof in this area. Recommend hiring a reputable contractor. Roof is very steep. (see photo 1).

Down spout draining onto roof

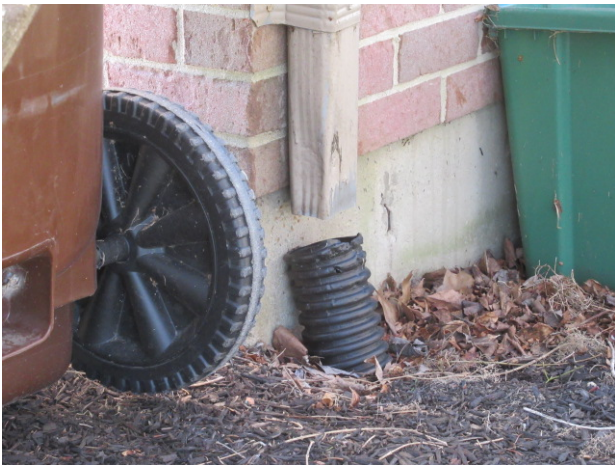
#R3

2. Gutters are clean other than some shingle granules. Typical for a roof of this age. (see photo 2).
3. Down spout on the front right side of house has become disconnected from the drain pipe. Recommend extending down spout into drain pipe to help avoid possible water intrusion and damage to concrete slab. (see photo 3).

Down spout disconnected from drainage pipe

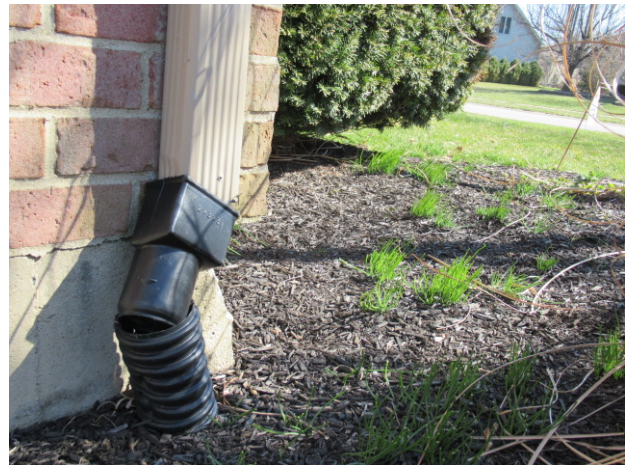
#R4

4. Down spout on the front left side of house has become disconnected from the drain pipe. Recommend extending away from foundation to help avoid possible water intrusion and damage to foundation. Unsure of where the buried drain pipe is draining to. (see photo 4).

Down spout disconnected from drain pipe

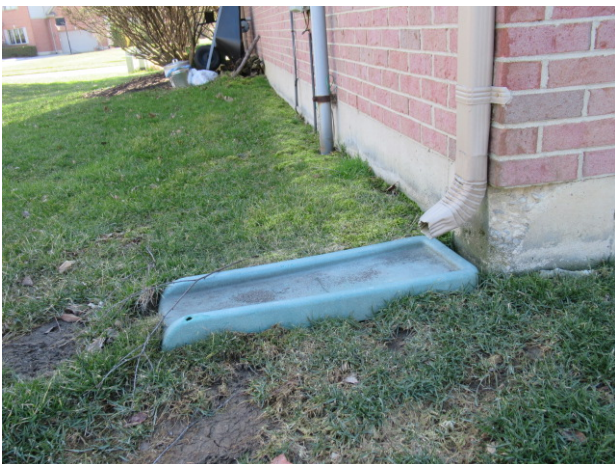
#R5

5. Down spout trough is leaning back towards the house (back left of house). I recommend building the grade up against the house to help water drain away from foundation. (see photo 5).

Down Spout trough is leaning slightly towards foundation

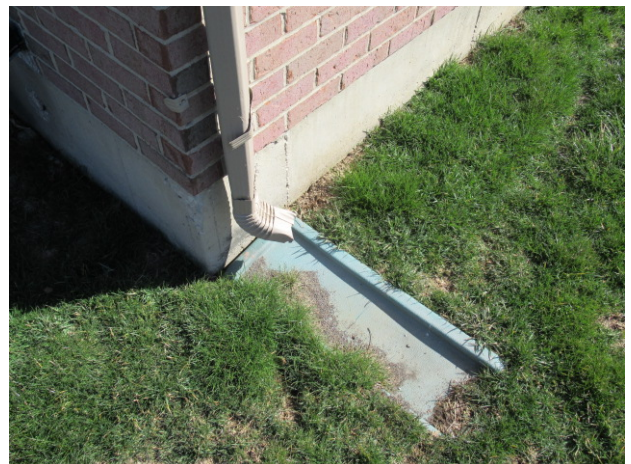
#R6

6. Down spout trough is not going to be effective in this position (back right of house). I recommend building the grade up against the house to help water drain away from foundation. (see photo 6).

Trough is not placed correctly

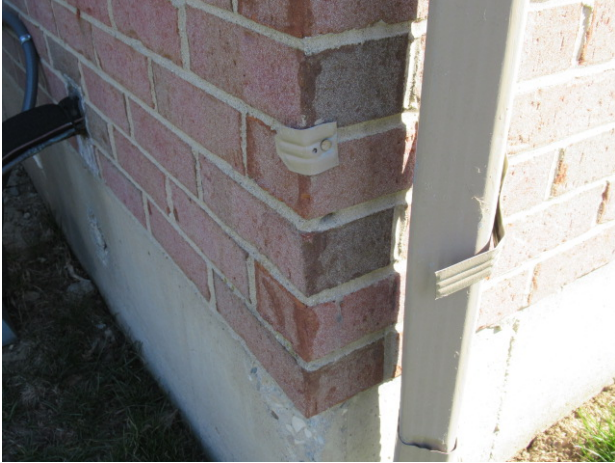
#R7

7. Down spout strap has snapped exposing sharp metal edges. Could cause injury if someone unknowingly brushed up against it. Recommend replacement. (see photo 7).

Broken down spout - Sharp edges

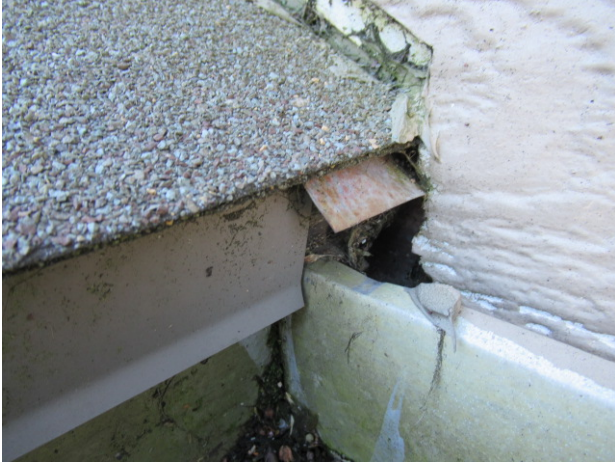
#EX1

1. Defective flashing above gutter over back door. Recommend repair or replacement to avoid possible water and pest intrusion. (see photo 1).
2. Paint and caulk in poor condition behind down spout on roof above garage. I recommend scraping off old paint and caulk. Resealing, and repainting to avoid water intrusion and wood rot. (see photo 2).

Loose flashing above gutter - Above back door

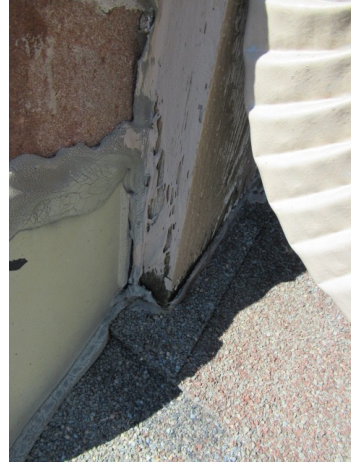
#EX2

Paint and caulking damaged behind down spout on roof above garage

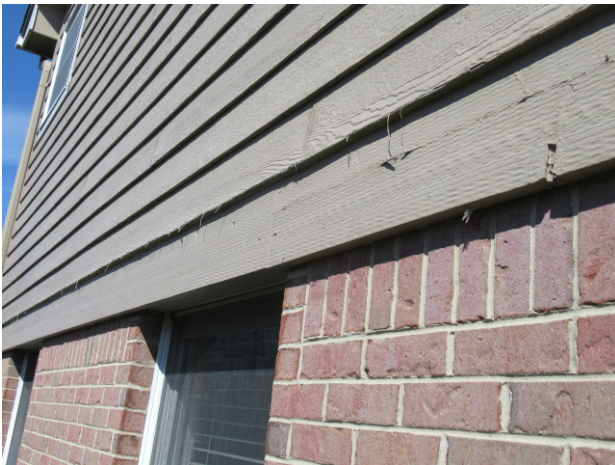
#EX3

3. Chipped paint on drip edge around the majority of house. Recommend scraping off and repainting to avoid wood rot. (see photo 3).
4. Many windows have deteriorating caulk around the trim. Recommend removal of old caulk, then resealing. (see photo 4).

Paint on drip edge is in poor condition

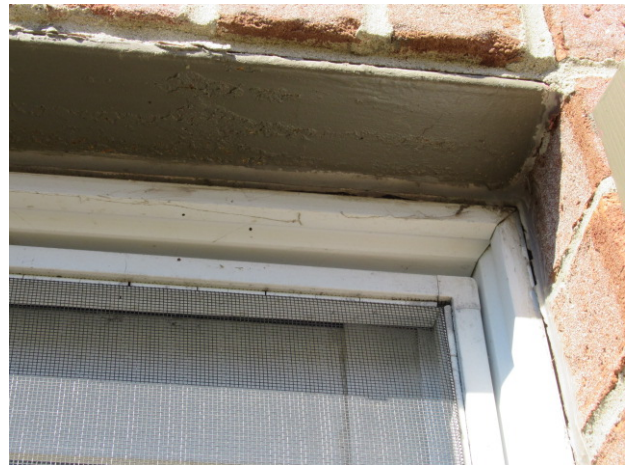
#EX4

Multiple windows need to be recaulked around trim

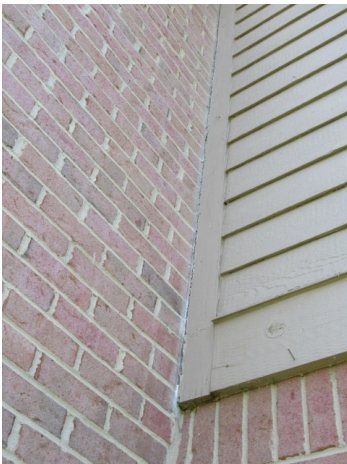
#EX5

5. Inside corners where the siding butts up against chimney have deteriorating caulk. Recommend removing, then re-caulking to avoid possible water intrusion and rot. (see photo 5).

Caulk between chimney and siding is in poor condition

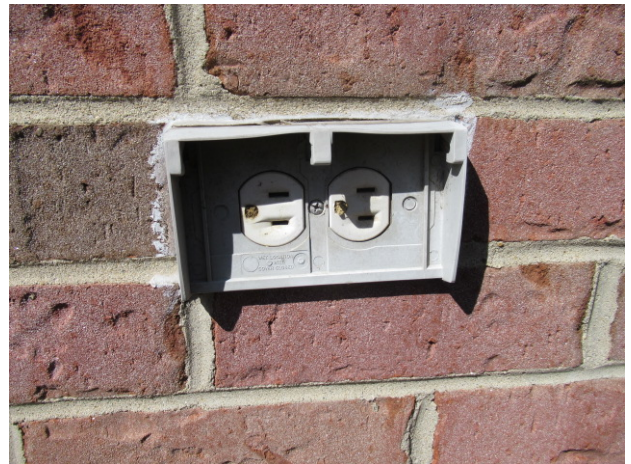
#EX6

6. Missing cover on outlet next to the front door. Recommend repair or replacement to keep out water and insects. I was unable to test this outlet due to mud daubers. (see photos 6,7).

Missing outlet cover - Front of house

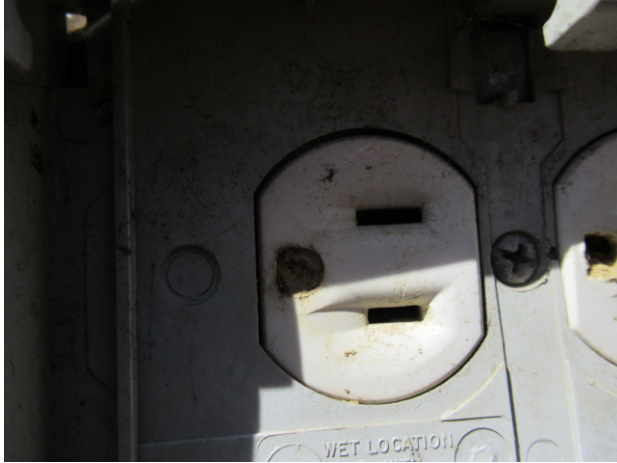
#EX7

Unable to test front outlet due to mud daubers

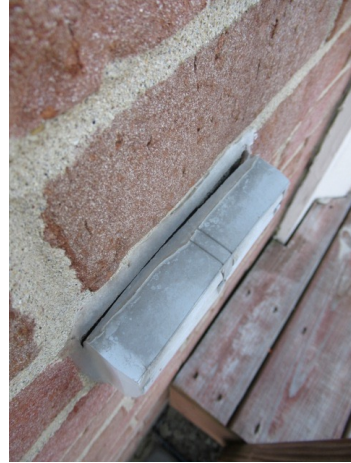
#EX8

Outlet just off back porch - Missing caulk

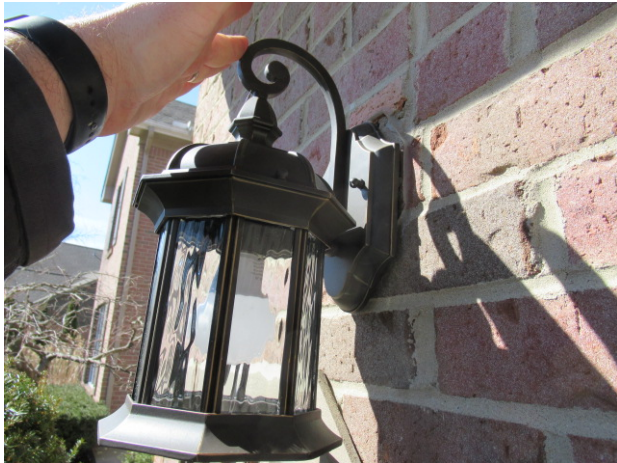
#EX9

8. Loose light fixtures on both sides of garage and next to back door. Recommend hiring an electrician to securely fasten to walls, then caulk to avoid water and pest intrusion. (see photos 9, 10, 11).

Light fixture is loose - left side of garage

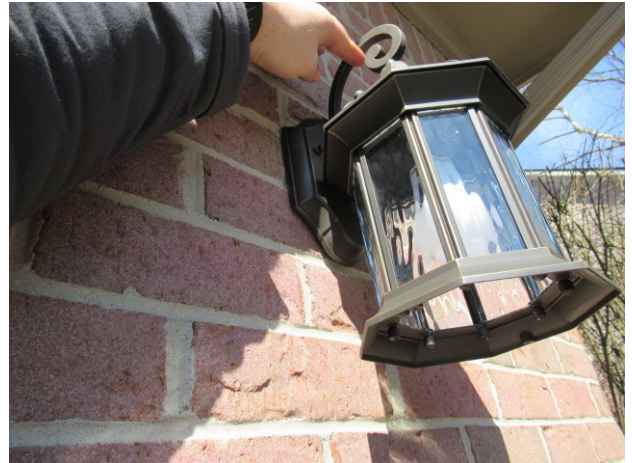
#EX10

Light fixture is loose - right side of garage

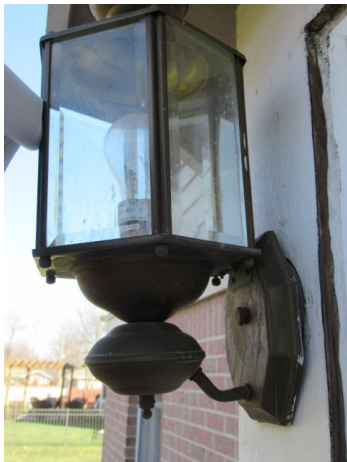
#EX11

Light fixture is loose - back porch

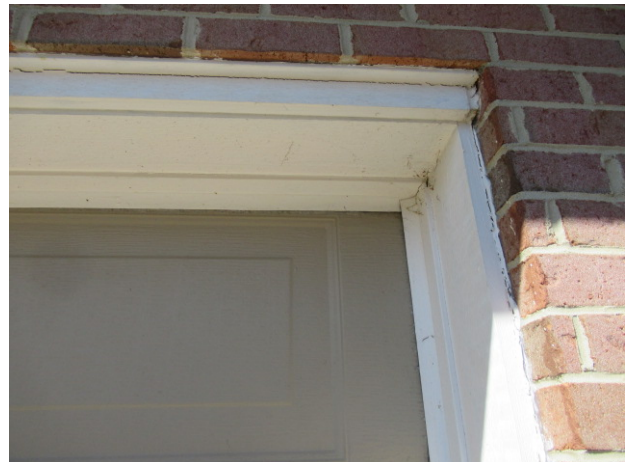
#EX12

9. Caulk is in poor condition around garage door trim. Recommend removal and re-caulking to avoid possible water intrusion. (see photo 12).
10. Paint is in poor condition on base of garage door trim and wood is starting to rot. It's not too far gone though. Recommend repainting to help avoid further water intrusion and rot. (see photo 13).

Caulk is in poor condition around garage door trim

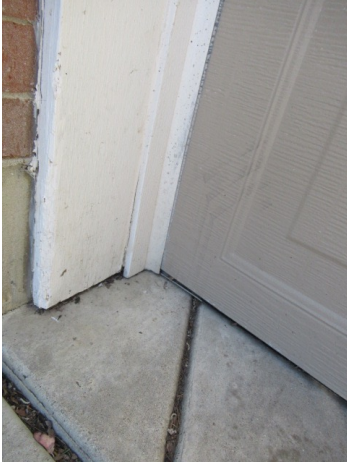
#EX13

Paint in poor condition at base of garage door trim

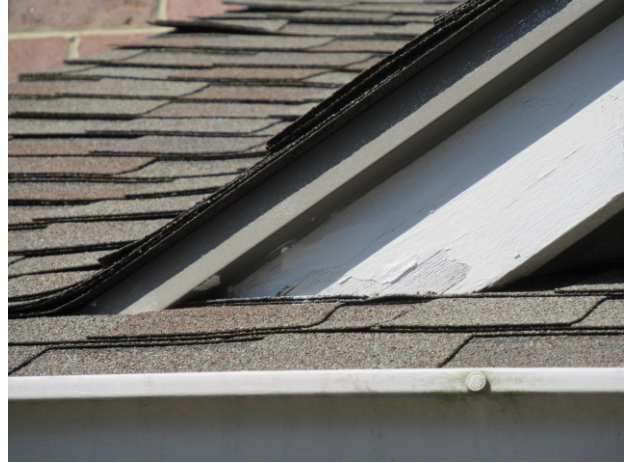
#EX14

11. Paint is cracked and chipping on fascia board above garage door (both sides). Recommend removal of damaged paint then repainting to avoid further damage to wood. (see photos 14,15).

Paint chipping on fascia above garage - Front of house

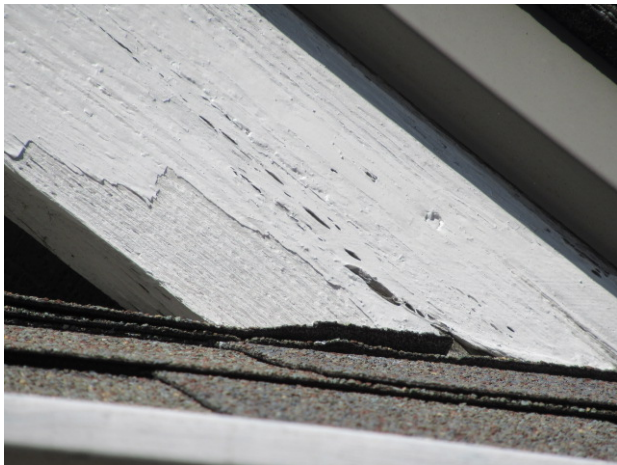
#EX15

Paint chipping on fascia above garage - Front of house

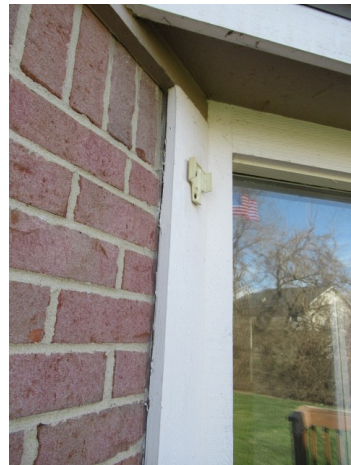
#EX16

12. Missing caulk - Trim next to windows on back deck. Recommend caulking to avoid possible water and pest intrusion. (see photo 16).
13. Base of trim, and threshold of sliding door in rear has damaged/missing paint. Recommend repainting to avoid water intrusion and wood rot. (see photo 17).

Caulk in poor condition on trim - to the left of window over the porch

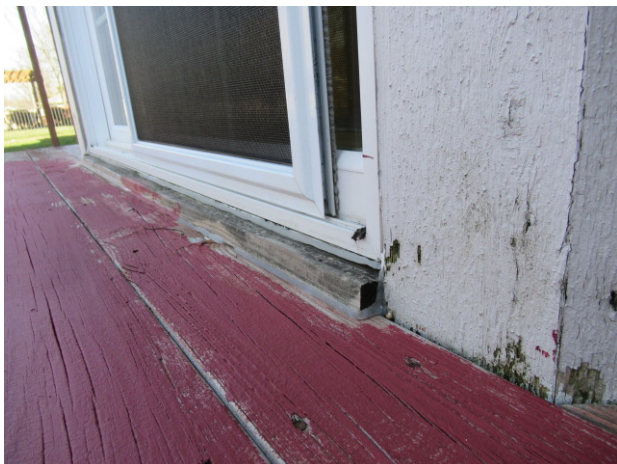
#EX17

Trim and threshold paint are in poor condition - Wood beginning to show signs of rot

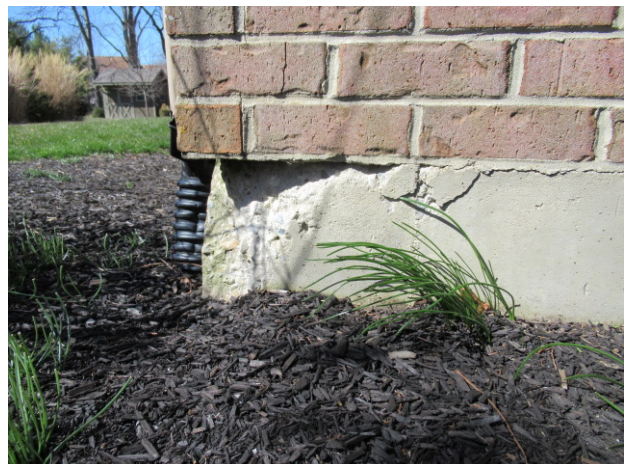
#EX18

14. Damaged foundation corner on the front left side of house. Damage appears to be old. Recommend hiring a reputable concrete contractor to repair to avoid further deterioration. Or sealing to keep water from penetrating which can lead to further damage. (see photo 18).

Corner of foundation damage - front left of home

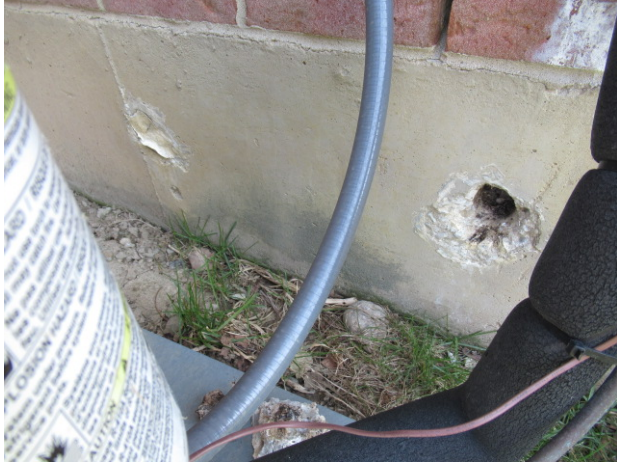
#EX19

15. Holes in foundation from previous air conditioner. Recommend sealing with caulk or concrete to avoid water and pest intrusion. (see photo 19).
16. There are a couple of settling cracks in foundation in different spots around the house. Recommend sealing with a high quality caulk (Quad) to avoid water intrusion which can lead to further damage to the foundation. (see photo 20).

Holes from previous air conditioner in foundation

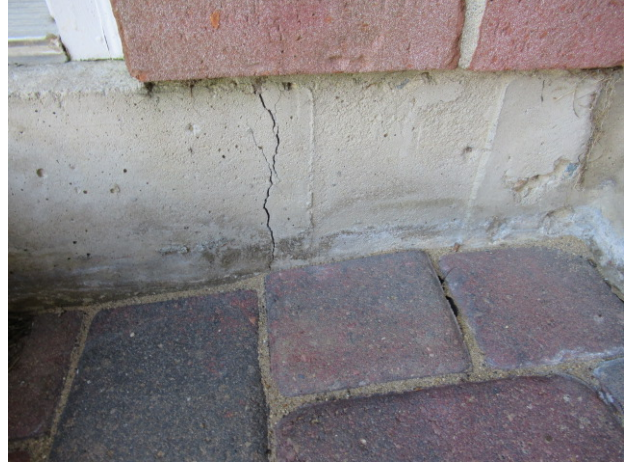
#EX20

Example of minor settling cracks in foundation

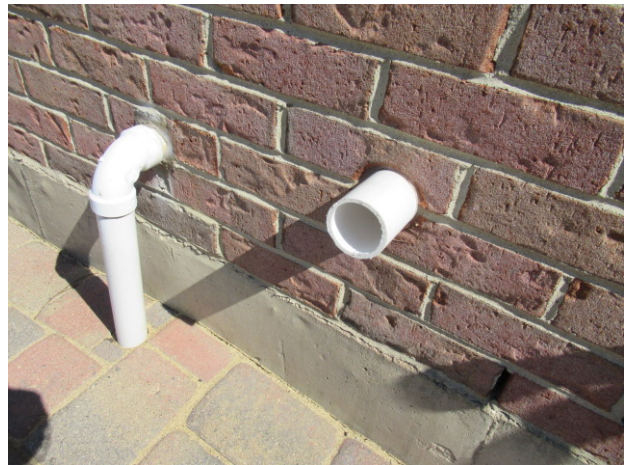
#EX22

17. Unpainted trim around sliding door. Recommend painting to avoid water intrusion and wood rot. (see photo 21).
18. Sump pump discharge pipe on back patio. Recommend extending away from house to keep water from draining back towards foundation. (see photo 22).

Open pvc pipe to the left of back porch - Most likely for the sump pump

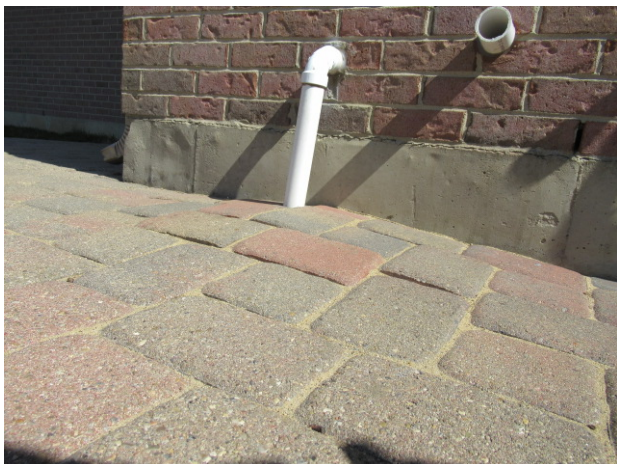
#EX23

Bulge in brick patio

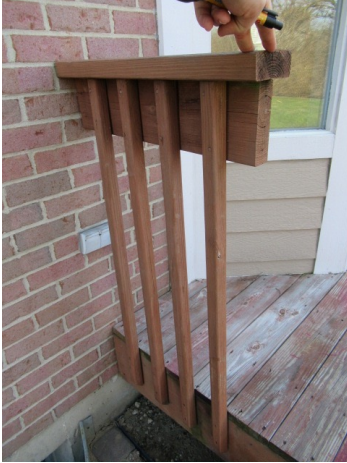
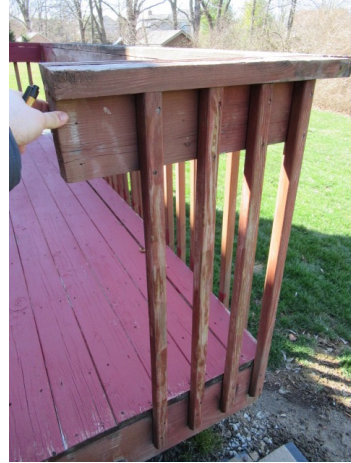
#GD1

1. Improperly secured rail on rear deck. Recommend repair or replacement to avoid possible bodily injury. (see photos 1,2).
2. There are a couple nail pops on deck surface. Recommend repair or replacement to avoid possible bodily injury if someone is walking barefoot. (see photo 3).

Improperly secured rail on back porch

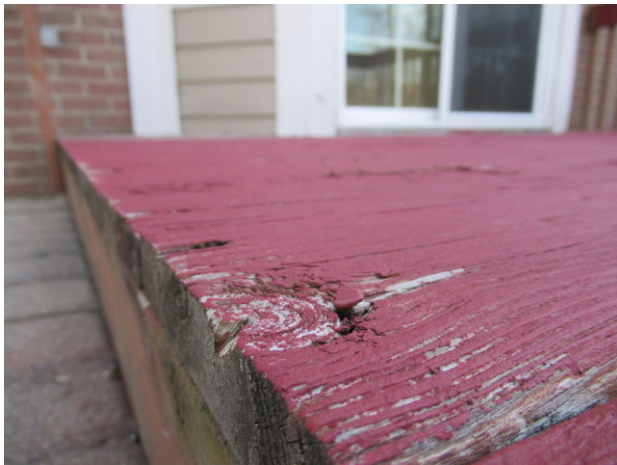
#GD3

Multiple nail pops on deck

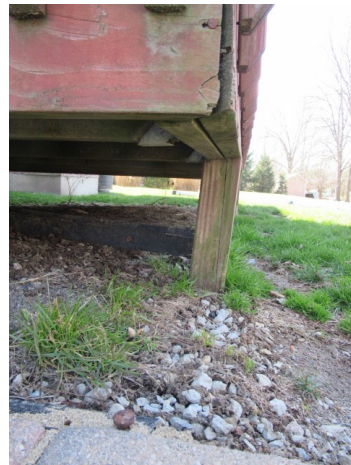
#GD4

3. Insufficient deck support. Both posts are leaning away from house. Recommend removal and replace with stronger support posts. (see photo 4).
4. Block steps leading to rear deck. Blocks are securely fastened currently, but if construction adhesive happens to fail. Someone could trip if a block pops up when stepping on the nose. (see photo 5).

Crooked deck supports

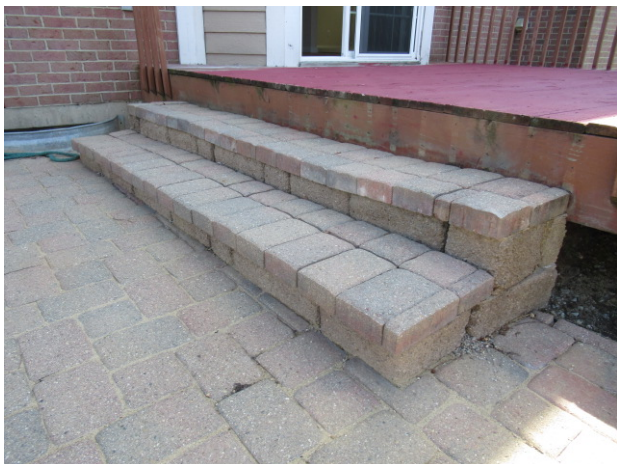
#GD5

Block stairs to porch - Could come loose

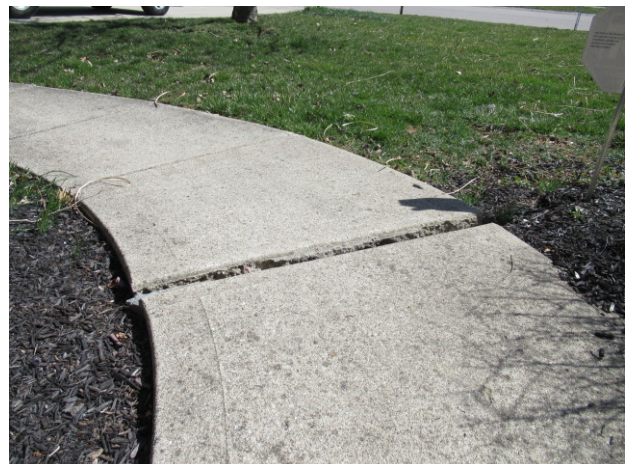
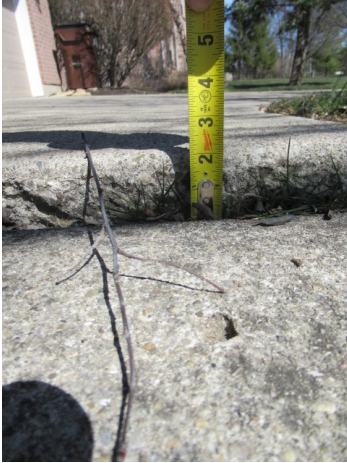
#GD6

6. Multiple tripping hazards on front walk leading to front door. Recommend repair or replacement by a reputable concrete contractor. (see photos 6,7).

Tripping hazard near the front step

Major tripping hazard on sidewalk near driveway

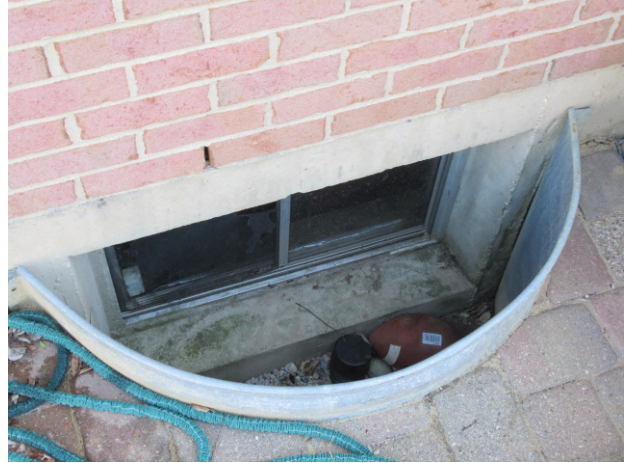
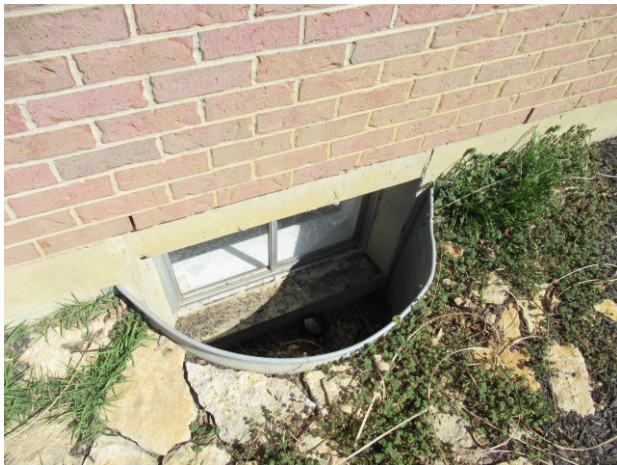
#GD8

7. Open window wells on side and rear of house. Recommend covering to avoid water intrusion and to keep someone from falling into them. (see photo 8,9).

Open window well

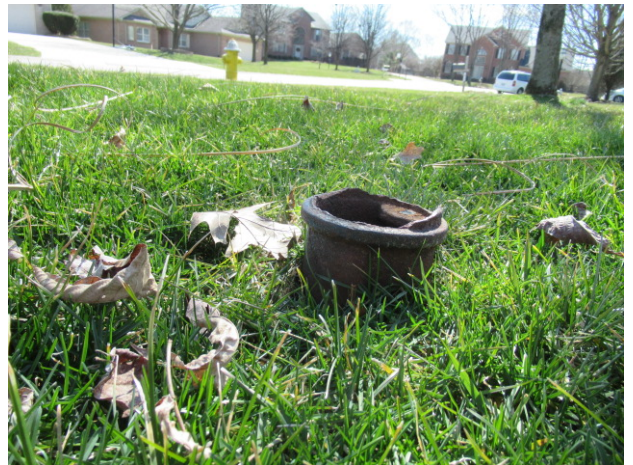
#GD10

8. Open gas shut off pipe in middle of front yard. Could cause someone to trip, or cause serious injury to a child if they get their foot stuck in it. (see photo 10).

Vectren pipe sticking up in front yard

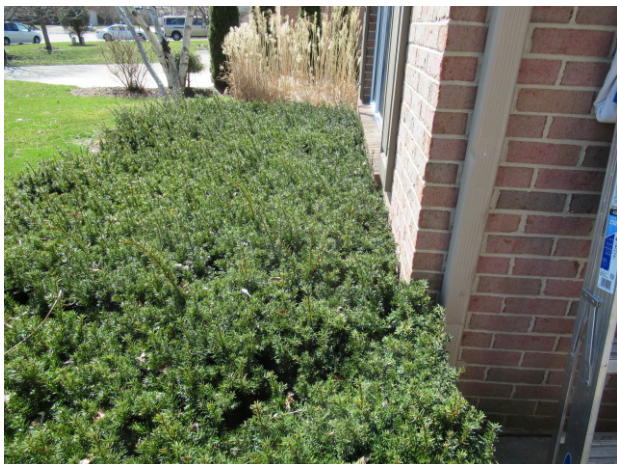
#GD11

9. Overgrown hedge in front of house. Recommend trimming back from house to avoid possible pest intrusion. (see photo 11).

Overgrown bushes in the front of house

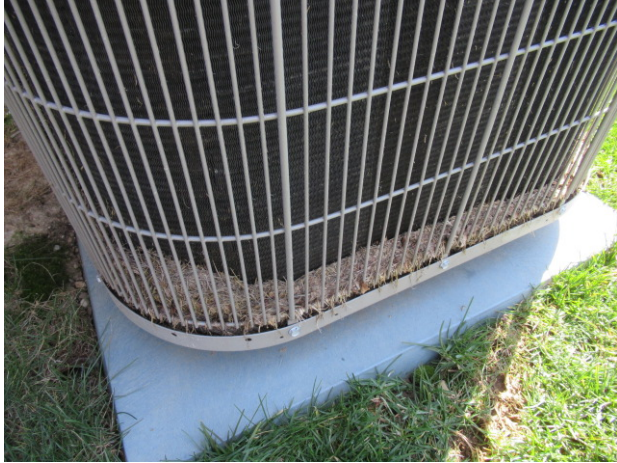
#HC1

1. Air conditioning was not tested as the outdoor temperature was below 60 degrees Fahrenheit. Running an air conditioner when it's below 60 degrees can damage the compressor. As the unit is newer and appears to be in great condition, I doubt there are any current issues.
2. Some debris in air conditioner. Recommend removing debris to avoid air flow obstruction and possible pest intrusion. (see photo 1).

Debris in air conditioner

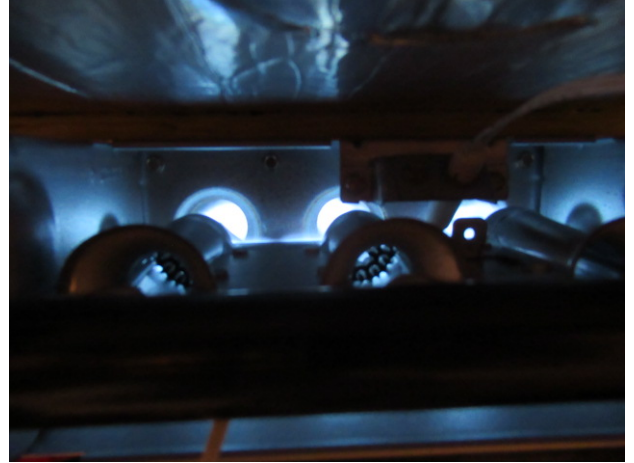
#HC2

3. Flames on furnace looked great. Unit is newer and very clean. Recommend yearly service by a reputable licensed HVAC company to ensure efficiency and safety. (see photo 2).

Flames in furnace look great!

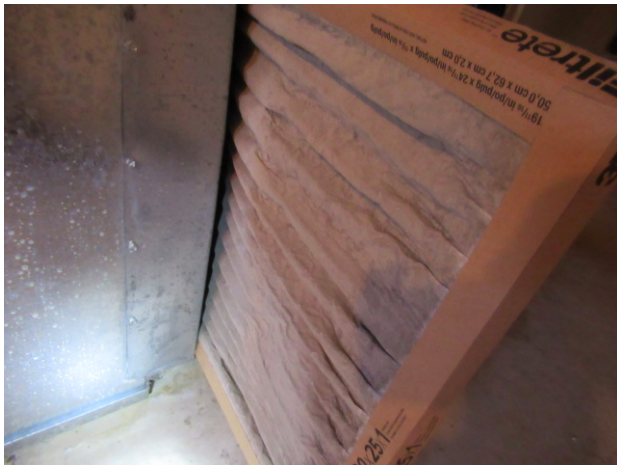
#HC3

4. Dirty filter. Recommend replacing filter monthly or bi monthly depending on how quickly it becomes dirty to ensure system efficiency. (see photo 3).

Dirty filter, needs replaced

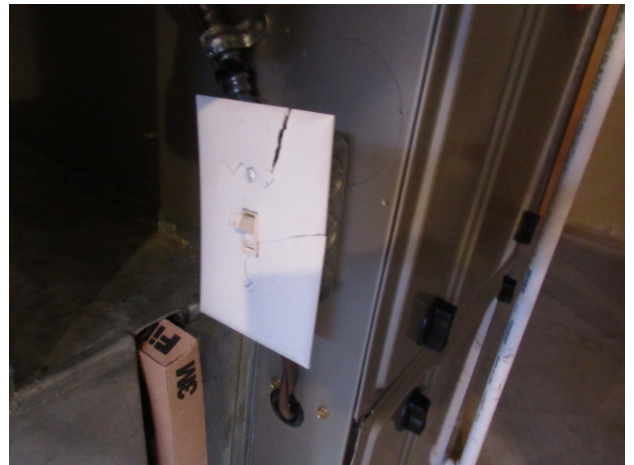
#HC4

5. Broken switch plate on furnace shut of switch. Recommend replacement. (see photo 4).

Broken plate on furnace shutoff switch

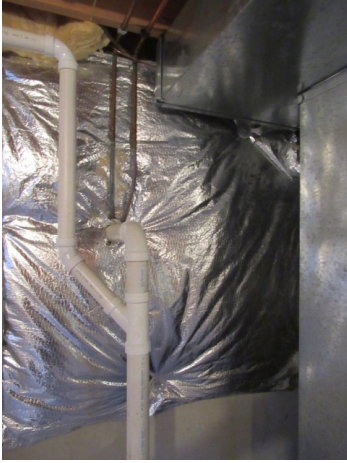
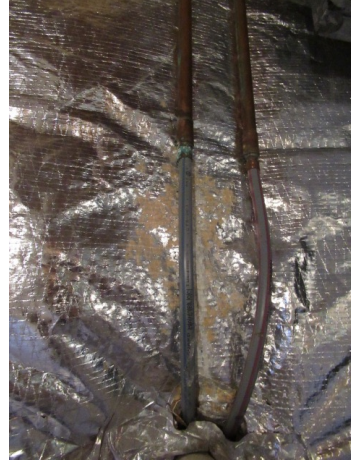
#P1

1. Possible water leak on supply pipes to the left of water heater. Leak appeared to be old, but I would recommend hiring a licensed plumber to inspect, repair or replace to make sure it does not spring a major leak and cause water damage to the surrounding area. (see photos 1,2).

Evidence of water leak from hose - to the left of furnace

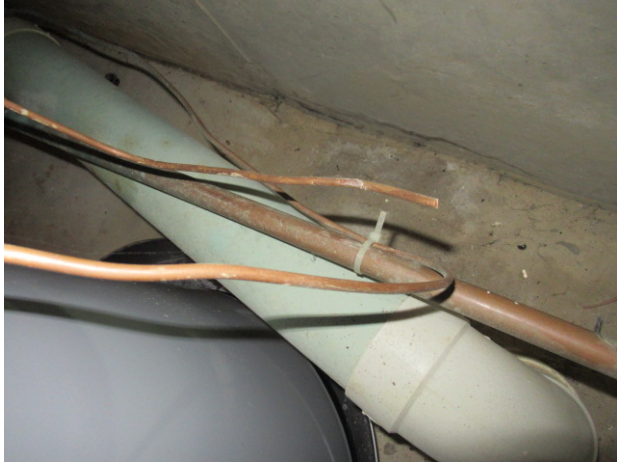
#EL1

1. Grounding attached to plumbing using a zip tie. It will function properly like this, but plastic can become brittle and break over time. Recommend attaching to pipe using a metal grounding clamp. (see photo 1).

Zip tie used to attach ground to water pipe

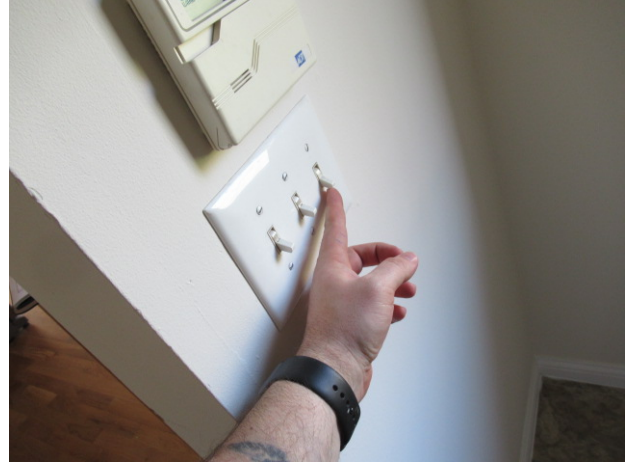
#EL2

Switch next to back door - Unsure of what it turns on/off

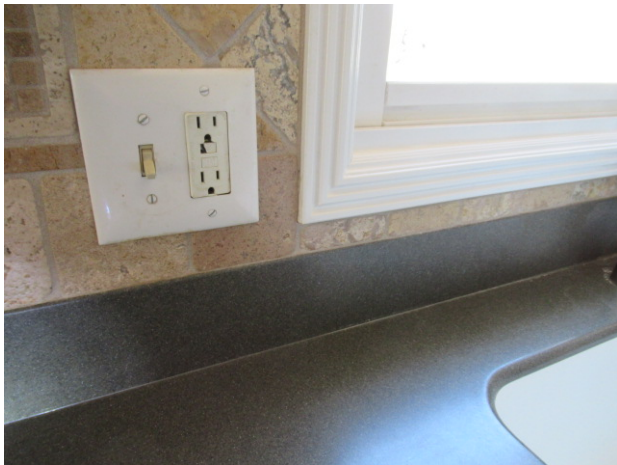
#EL3

3. Broken GFCI reset switch next to kitchen sink. Still functions. I recommend replacement by a licensed electrician. (see photo 3).

Broken reset switch - still functions
GFCI above desk in kitchen is not functioning (No pic)

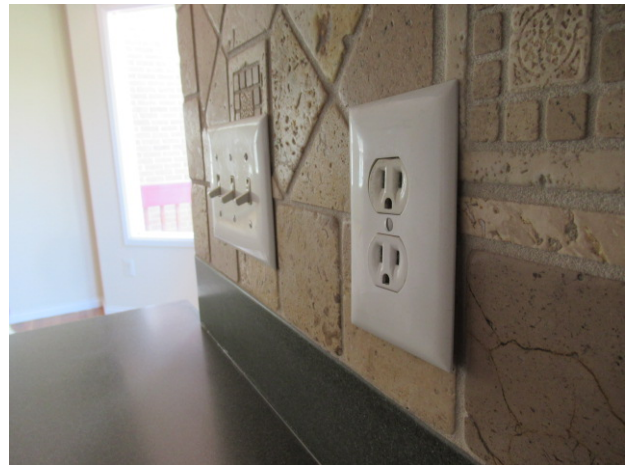
#EL4

4. Outlets on the left and right side of kitchen counter are not properly secured to their boxes. I recommend repair or replacement by a licensed electrician. (see photo 4).

Outlets/plates on left and right side of counter are loose on bottom

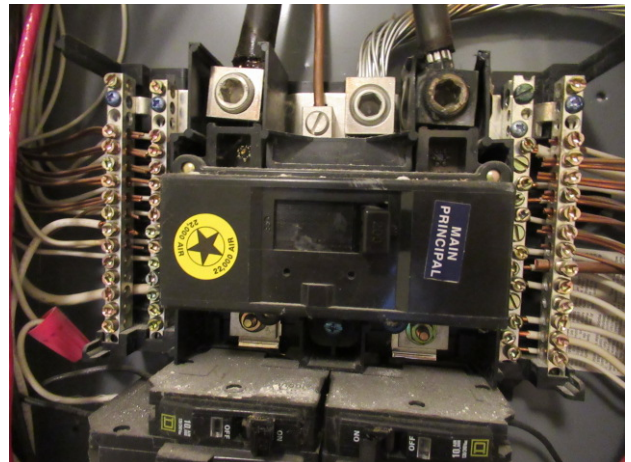
#EL6

6. No issues observed in electric panel. Pictures are FYI (see photos 5,6).

200 amp service

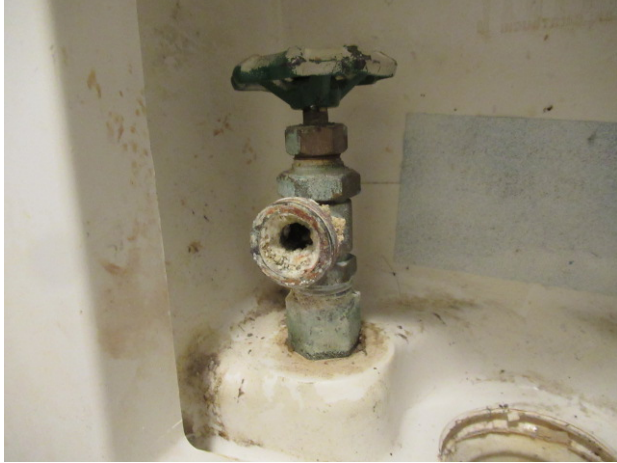
#K1

1. Sediment deposit on washing machine hookup. Recommend cleaning with a wire brush and using Teflon tape before attaching hose. Continue to monitor to make sure it is not leaking. (see photo 1).

Some sediment deposits on laundry hookup

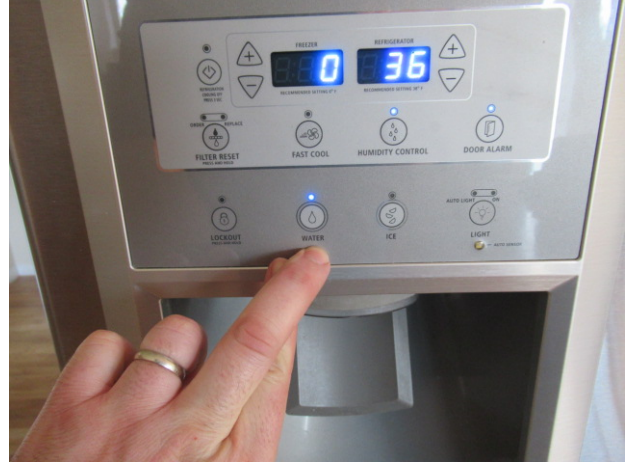
#K2

2. Water dispenser on refrigerator not functioning properly. Water only trickles out. Recommend replacing filter to see if that fixes the issue. (see photo 2).

Water dispenser on fridge not functioning properly

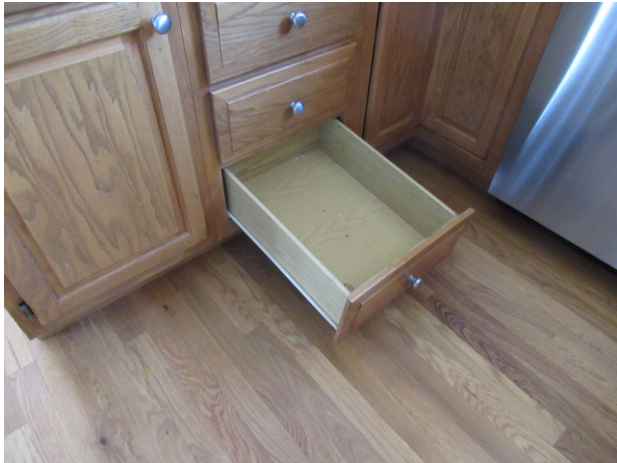
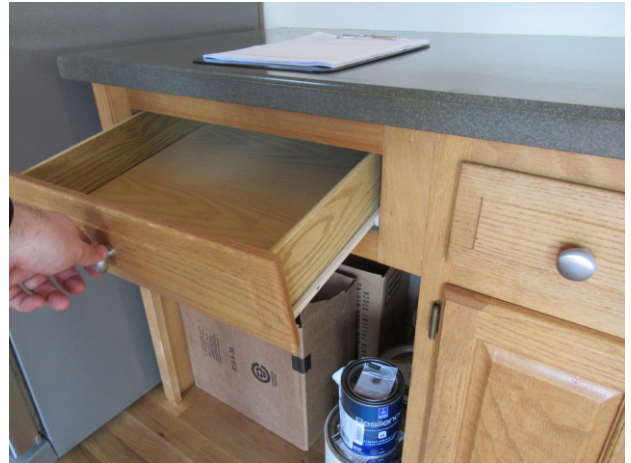
#K3

3. Broken drawer sliders on kitchen desk drawer, and on the bottom drawer of the peninsula. (see photos 3,4).

broken sliders - Bottom drawer

Broken drawer sliders on desk in kitchen

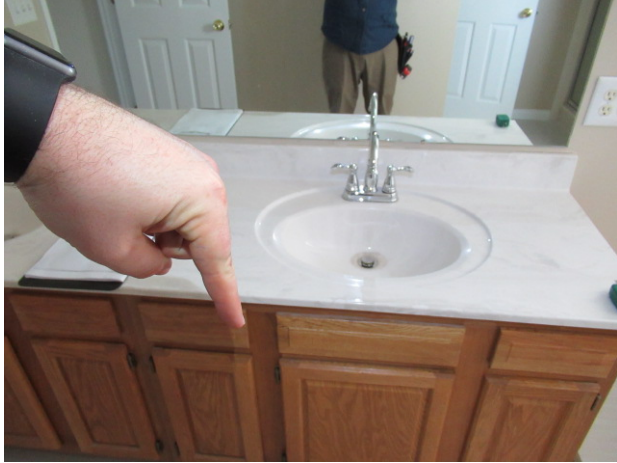
#B1

Right sink in master bathroom drains a little slow

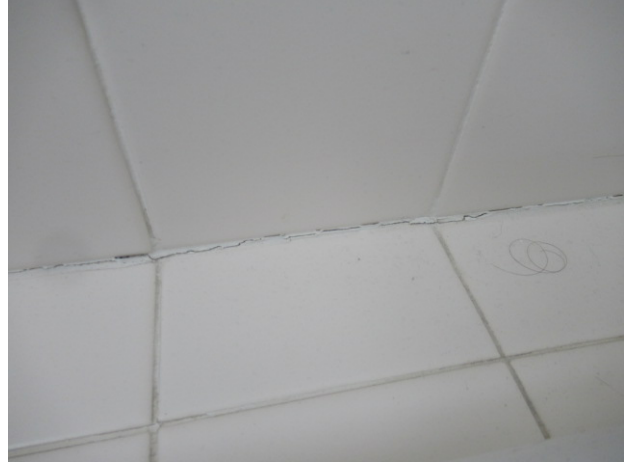
#B2

2. Inside corners of tile around Jacuzzi have caulking in poor condition. Recommend removing old caulk and sealing with new caulk to avoid possible water damage. (see photo 2).

Caulk in poor condition around Jacuzzi tub

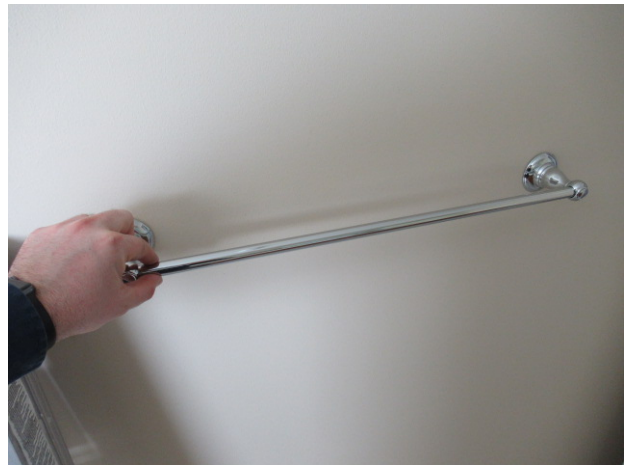
#B4

4. Loose towel rack in master bathroom. Recommend repair or replacement. (see photo 4).

Loose towel bar - master bathroom

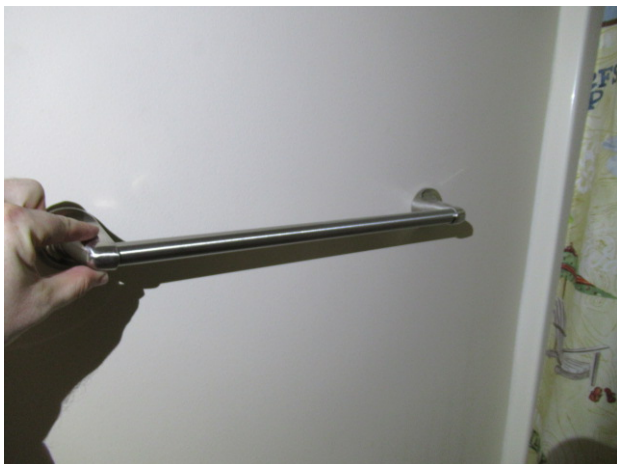
#B5

5. Loose towel rack in bathroom off the stairs. Recommend repair or replacement. (see photo 5).

Loose towel bar - upstairs bathroom

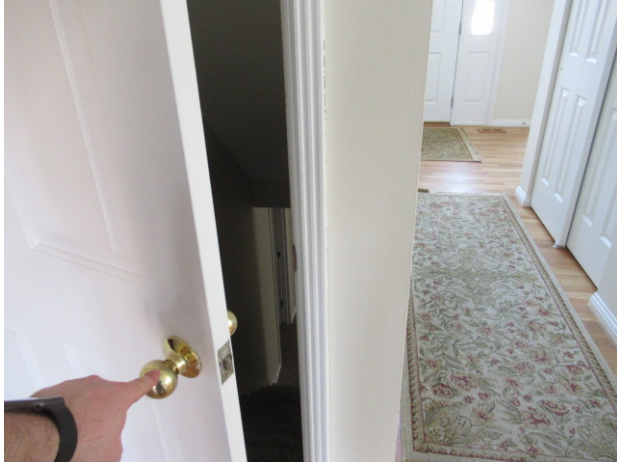
#IR1

1. Door knob to basement is not functioning properly. Knob must be turned to right in order to disengage latch. Recommend repair or replacement. (see photo 1).

knob only works when turned to the right

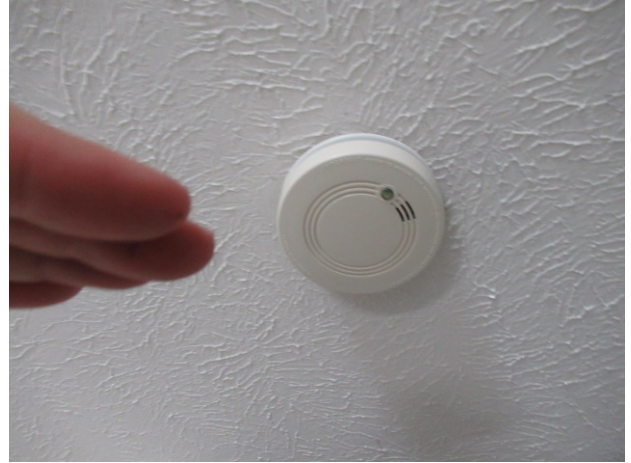
#IR2

2. SAFETY HAZARD - Smoke detector in basement beeps quietly when tested. All detectors in the house appear to be

yellowed and older. Detectors have a limited life span. The older they get, the less effective they become. I recommend replacing all smoke detectors. AT LEAST one per level of the house. (see photo 2).

Possibly defective smoke alarm in basement - beeped very quietly when tested

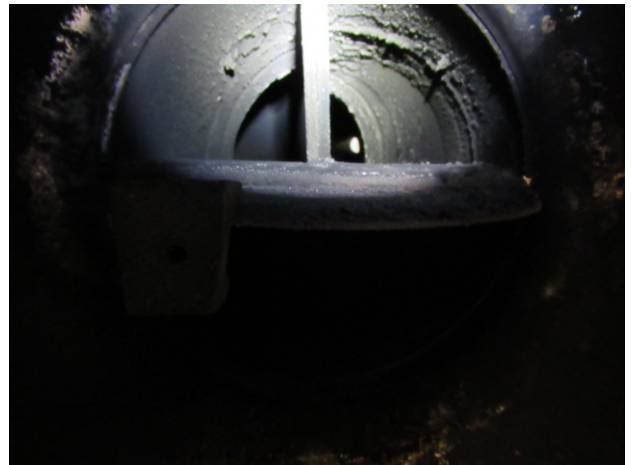
#IR4

5. Gas fireplace functioned when gas turned on and lit. Gas pressure is good. Does not appear that it has been used for a few years, as the flue pipe and firebox had quite a bit of dirt build up. Damper door does not close properly as well which could lead to energy loss and pest intrusion. I recommend cleaning out firebox, and having flue cleaned by a chimney contractor before use. If used regularly I highly recommend frequent cleaning and inspections by a chimney contractor. (see photo 4).

Light debris in chimney - damper does not fully close

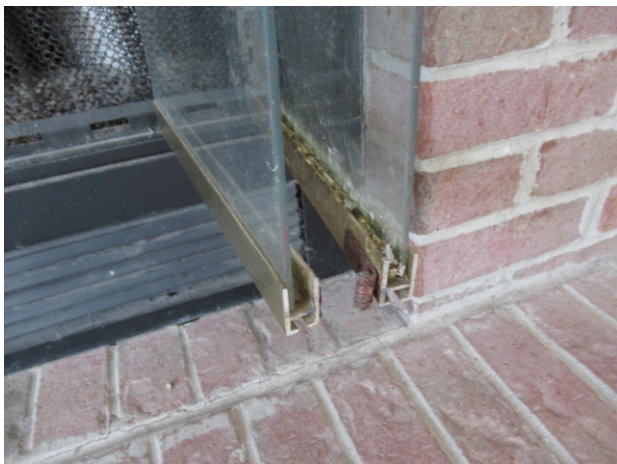
#IR5

6. Broken hinge on glass fireplace door. Recommend repair or replacement. (see photo 5).

Broken hinge on fireplace door

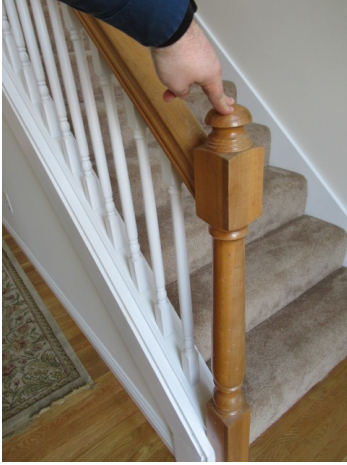
#IR7

8. SAFETY HAZARD - Hand rail leading upstairs is not secure. Wobbles heavily. Recommend repair or replacement by a reputable contractor. (see photo 7).

Improperly secured rail on stairs

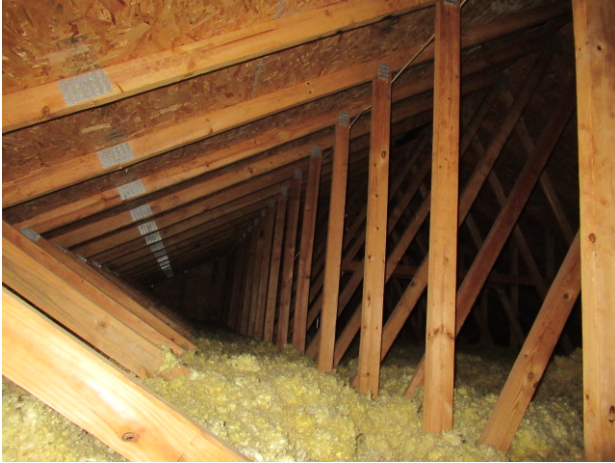
#AT1

Sufficient insulation

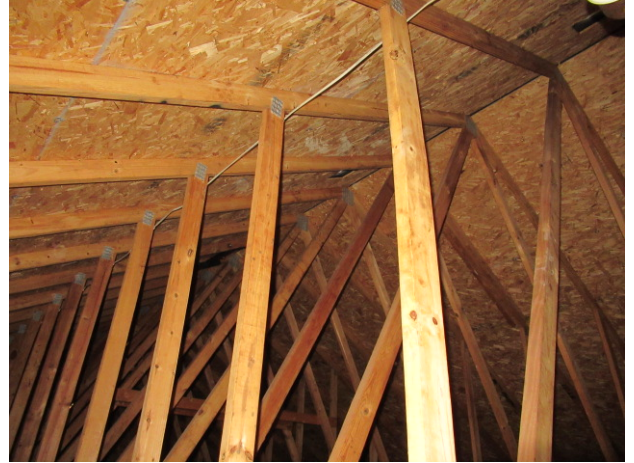
#AT2

OSB sheathing in excellent condition

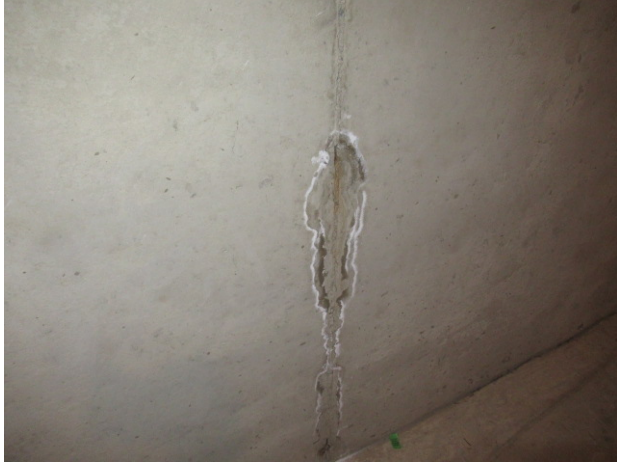
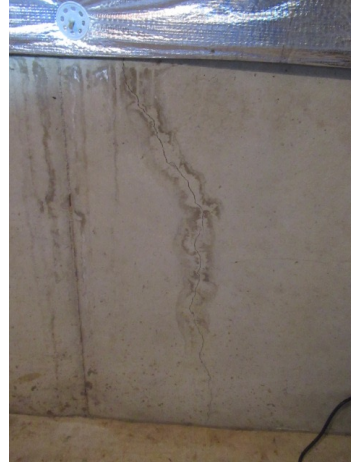
#F1

1. There are a couple very small settling cracks in foundation in the utility room. Some efflorescence (mineral deposits) around cracks lead me to believe water has leaked in at some point. This might be caused by the down spout on the back patio causing water to seep down between bricks and the foundation. I recommend injecting cracks with an Epoxy Crack injection repair kit. This will fill all gaps inside the foundation wall all the way to the outside of foundation. (see photos 1,2).

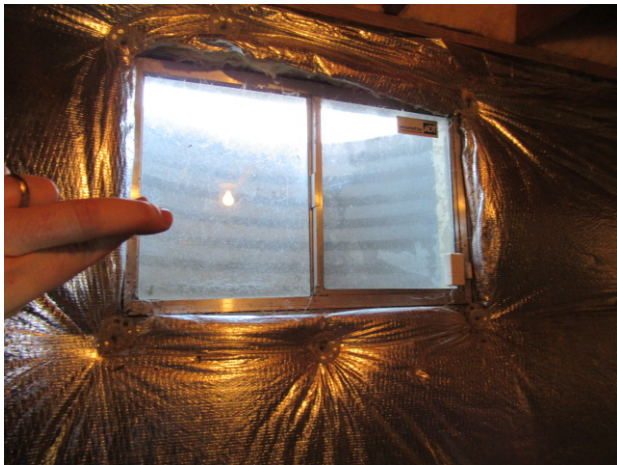
#F3

2. SAFETY HAZARD - Window in utility room is not functioning properly. Both windows in basement are single pane glass. Recommend removal and replacement to avoid a point of entry for unwanted visitors. Also, glass could cause bodily injury if broken. (see photo 3).
